CITY/TOWN <b>FREETOWN</b>	B.I.N. <b>3KQ</b>	BR. DEPT. NO. <b>F-09-003</b>	8.-STRUCTURE NO. <b>F09003-3KQ-MUN-NBI</b>	INSPECTION DATE <b>JAN 4, 2008</b>
------------------------------	----------------------	----------------------------------	-----------------------------------------------	---------------------------------------

ST 79 Elm Street has an east/west orientation. The bridge is in the tidal zone and the Assonet River flows from north to south.

### **ITEM 59 - SUPERSTRUCTURE**

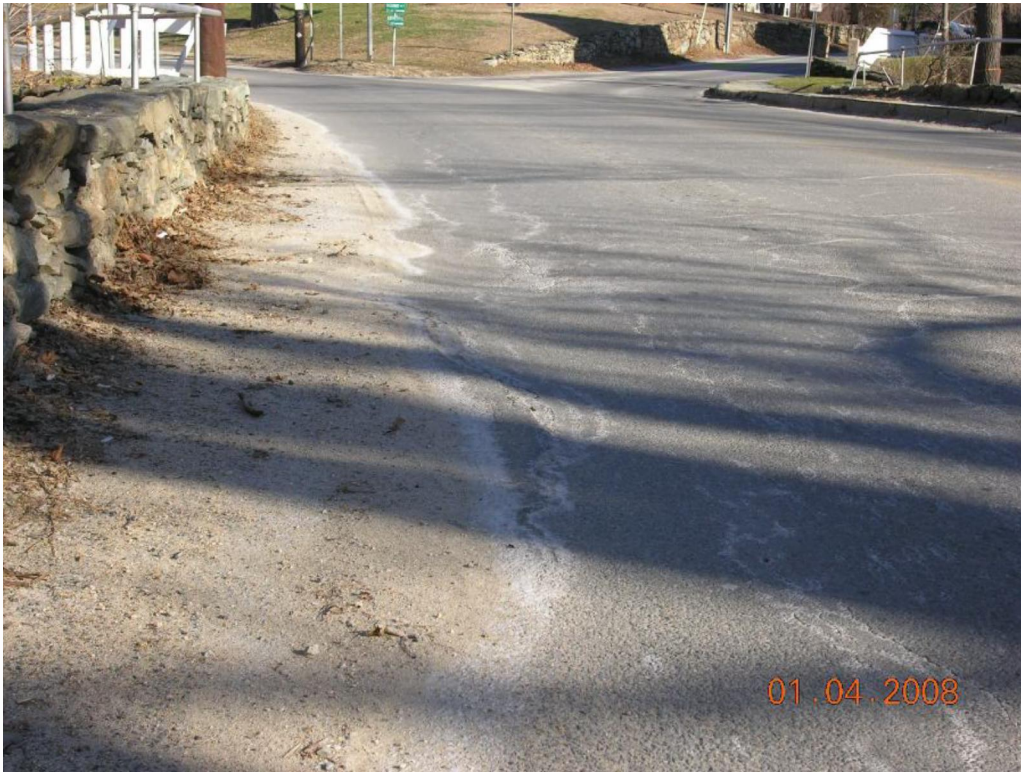
The north ends of all three arches are sagging 6 inches +/- with water dripping. The north side of the roadway above is settling and uneven, contributing unwanted vibration and impact loading in this area (Photo 1).

**Photo 1: Cracks, ruts, settling, and patched area, north side over middle barrel**

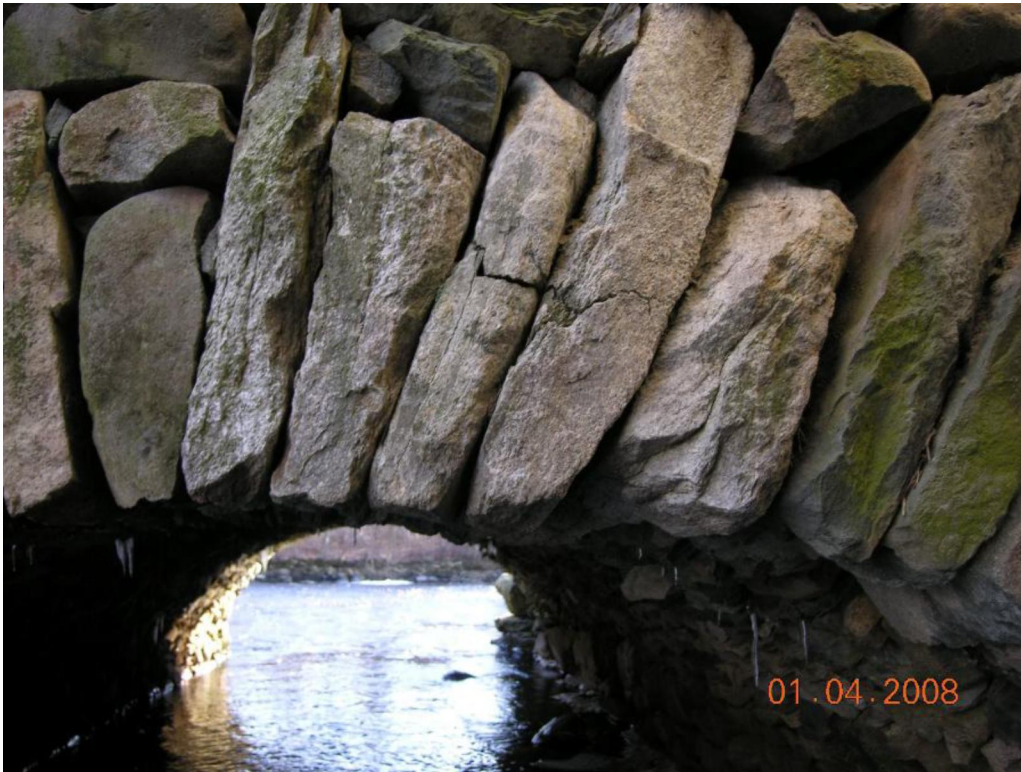
**Photo 5: West arch, north arch ring: Cracks in two stones**

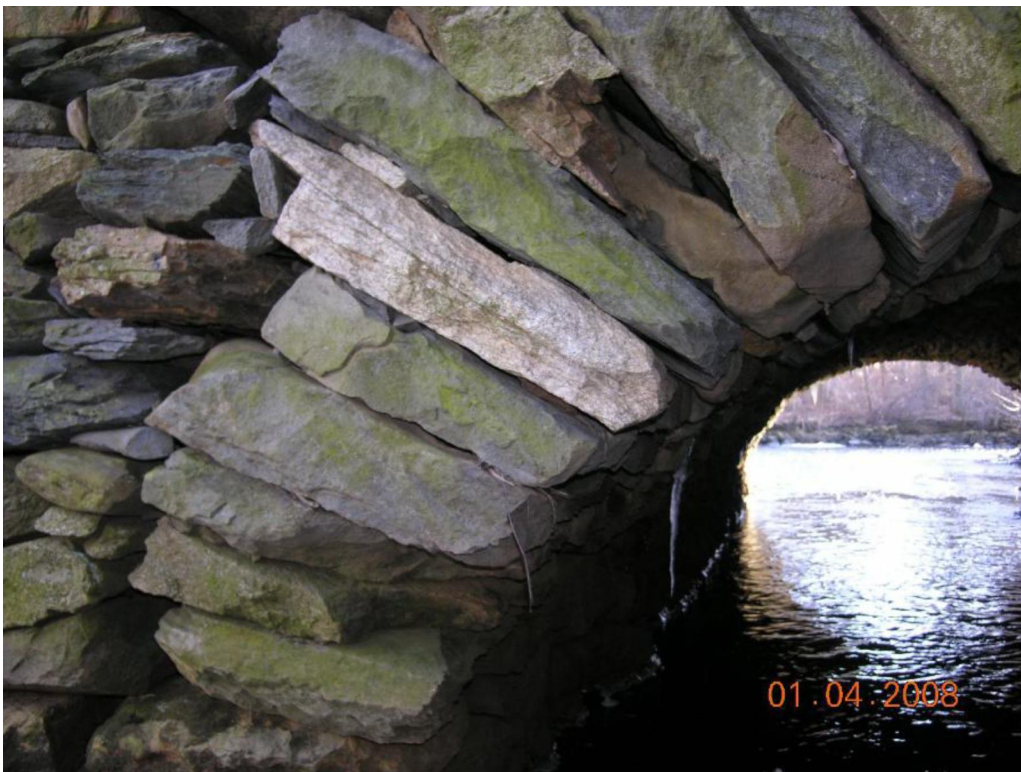
**Photo 6: West arch, north arch ring: Cracked and broken stones**

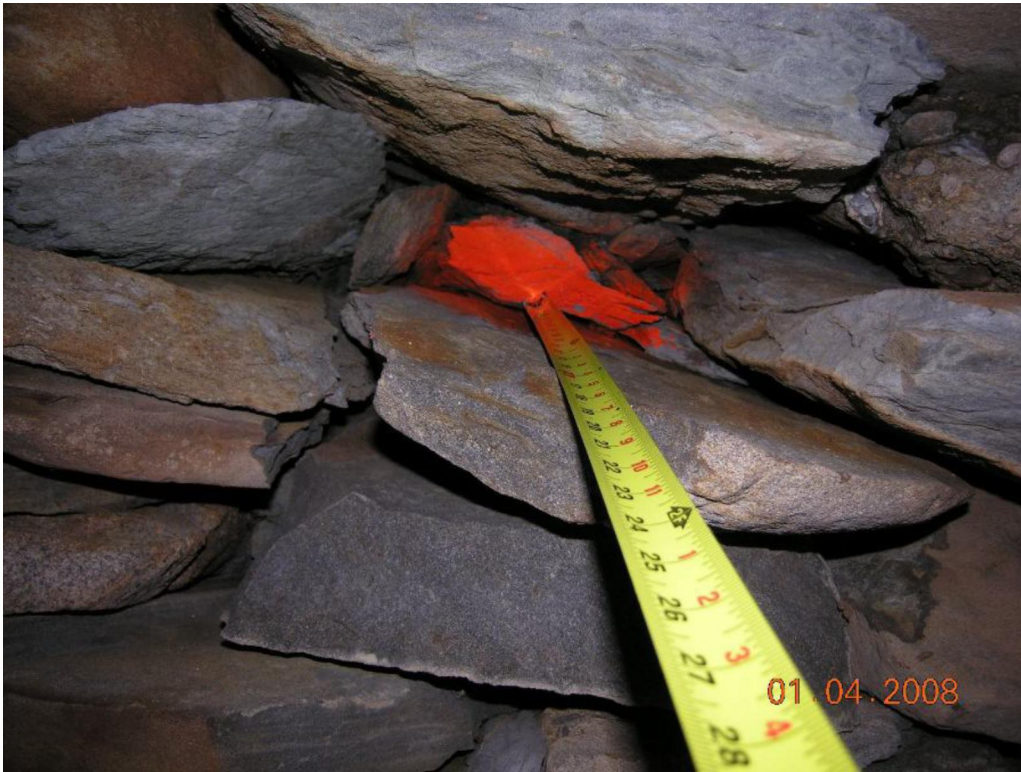
**Photo 7:** West arch at apex, 10-11ft from north at beginning of sag: Void 1ft x 6in x 16in D

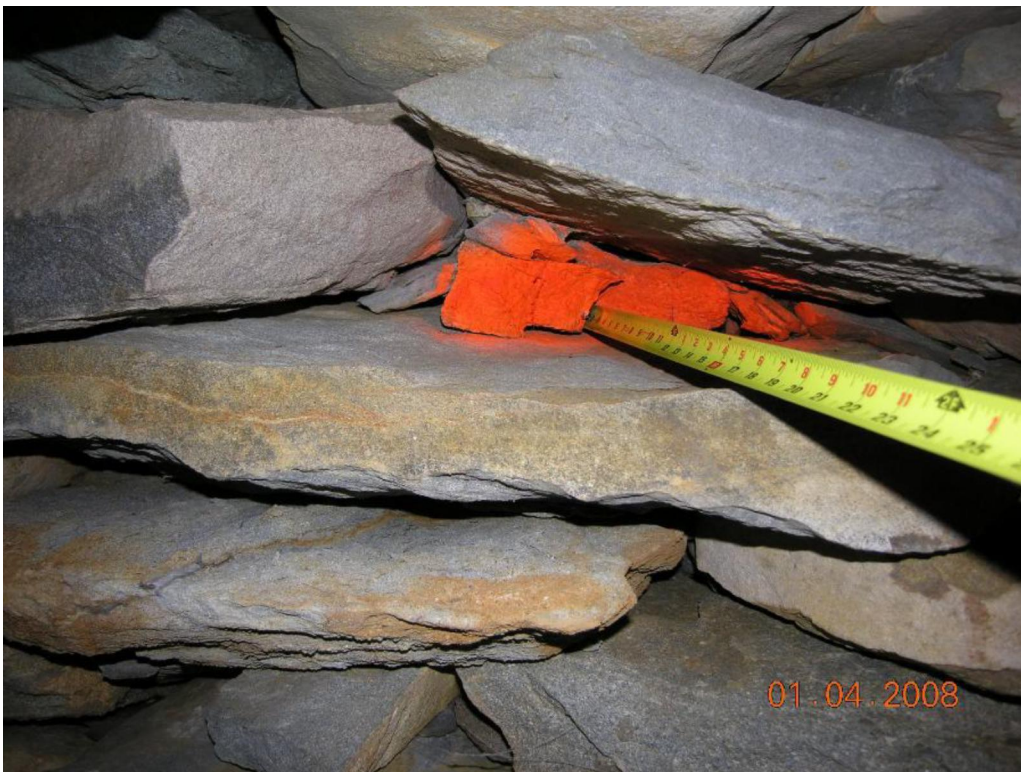
**Photo 8:** West arch at apex, 16-17ft from north: Void up to 1.5ft x 6in x 1.5ft D

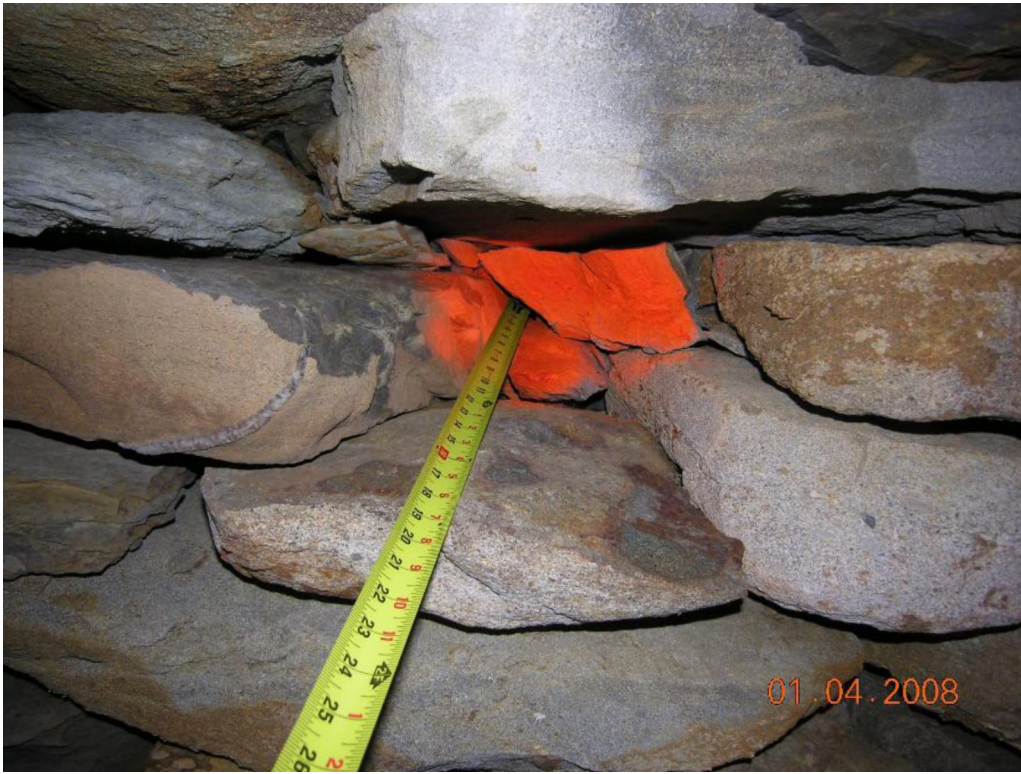
**Photo 9:** Void with fractured stone 2ft west of void in Photo 8: 1ft by 7in by 15in deep

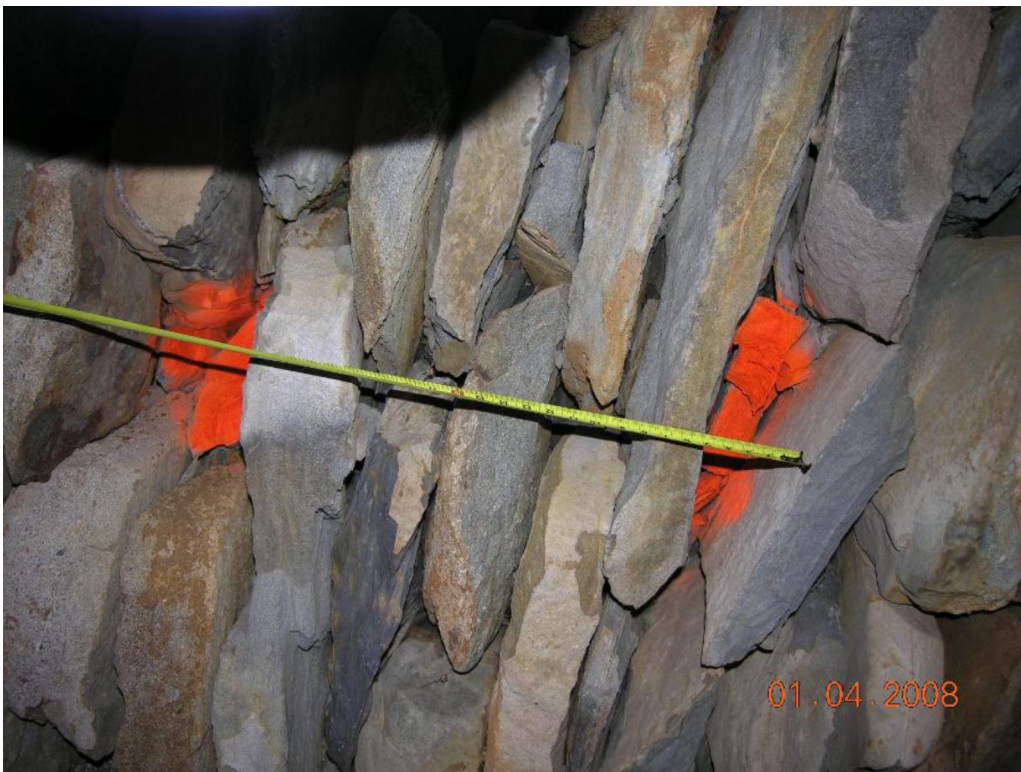
**Photo 10:** Voids shown in Photos 8 and 9

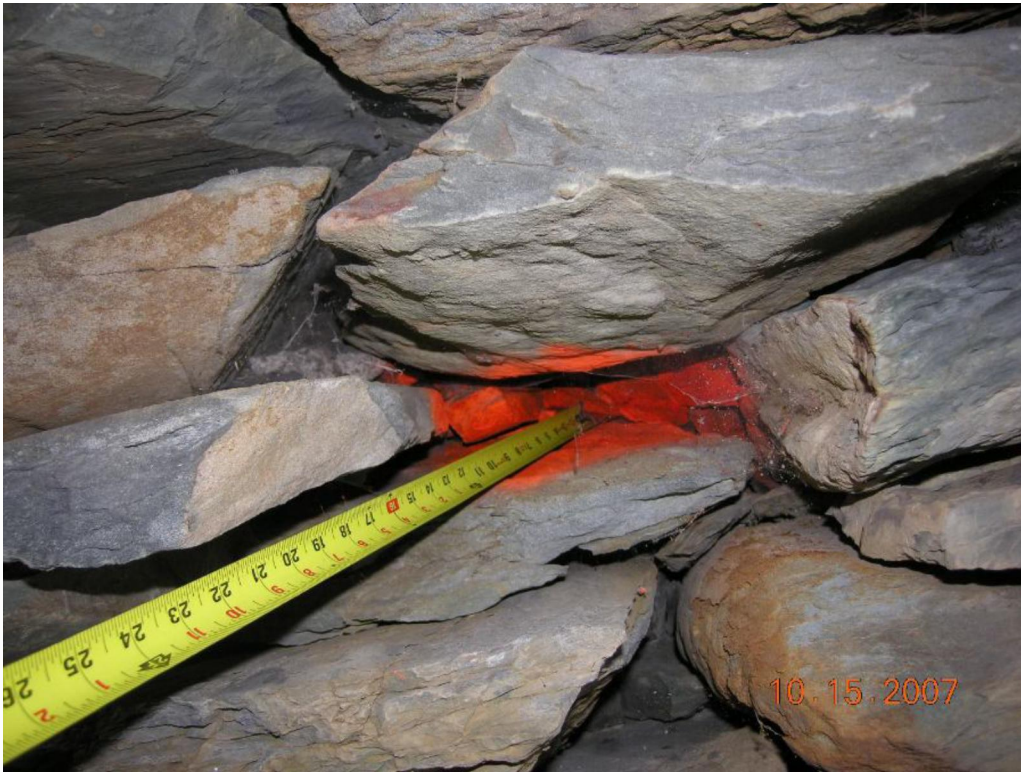
**Note:** Due to a camera malfunction, the photo taken of the void shown in Photo 11, Page 9, is not available. The photo from the previous inspection was included in this report for future comparison. There were no changes to this void.

**Photo 11: Void with fractured stone 7ft from south end of west arch, 10in by 6in by 2ft deep (Photo from 10/07 inspection - no change)**

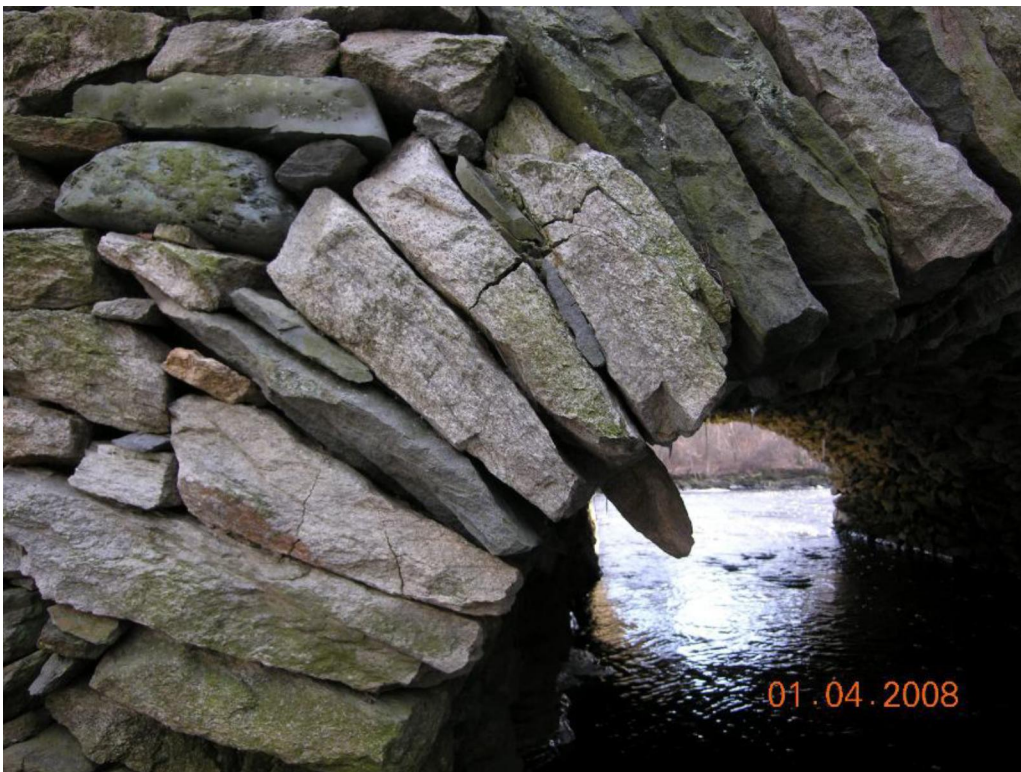
**Photo 14: Middle arch , north arch ring stones cracked at east; protruding stone inside of arch**

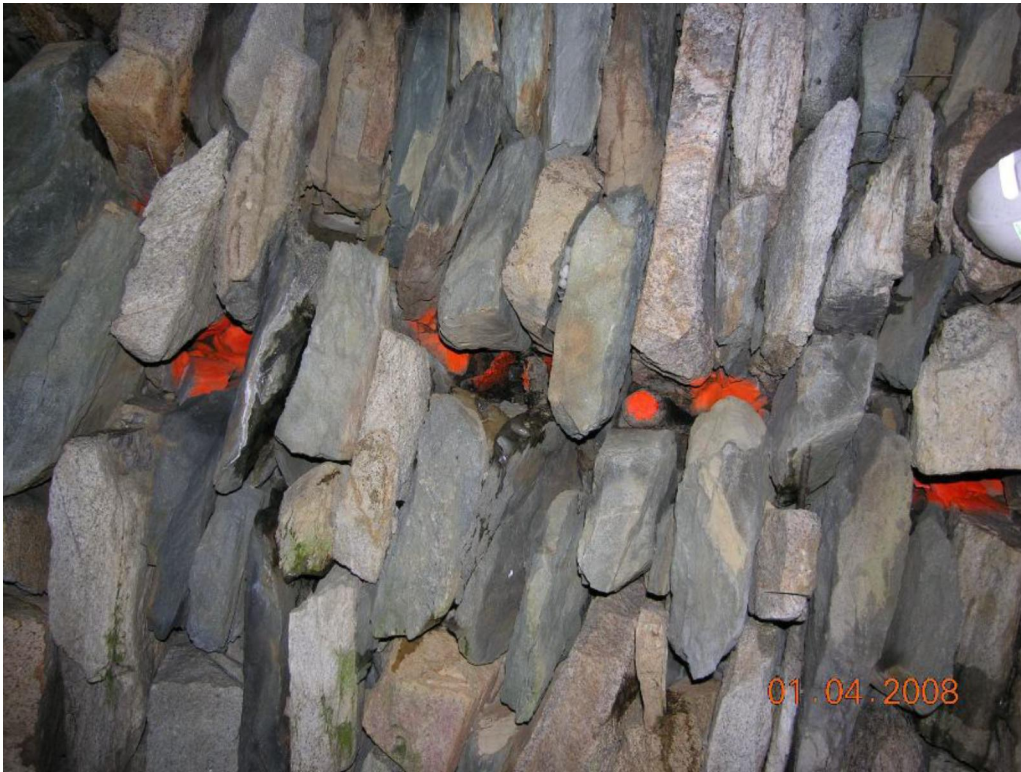
The sag in the west arch starts at a void 10 feet in from the north and continues to the arch ring. The middle arch sag has several 2ft deep voids that expose the gravel fill (Photo 15). There are freshly fallen fines and stones up to about 2in diameter in the stream bed under these voids. This sag extends 15 feet into the barrel and is under a settling patch in the wearing surface.

**Photo 15: Top of middle arch under settled area shown in Photo 1**

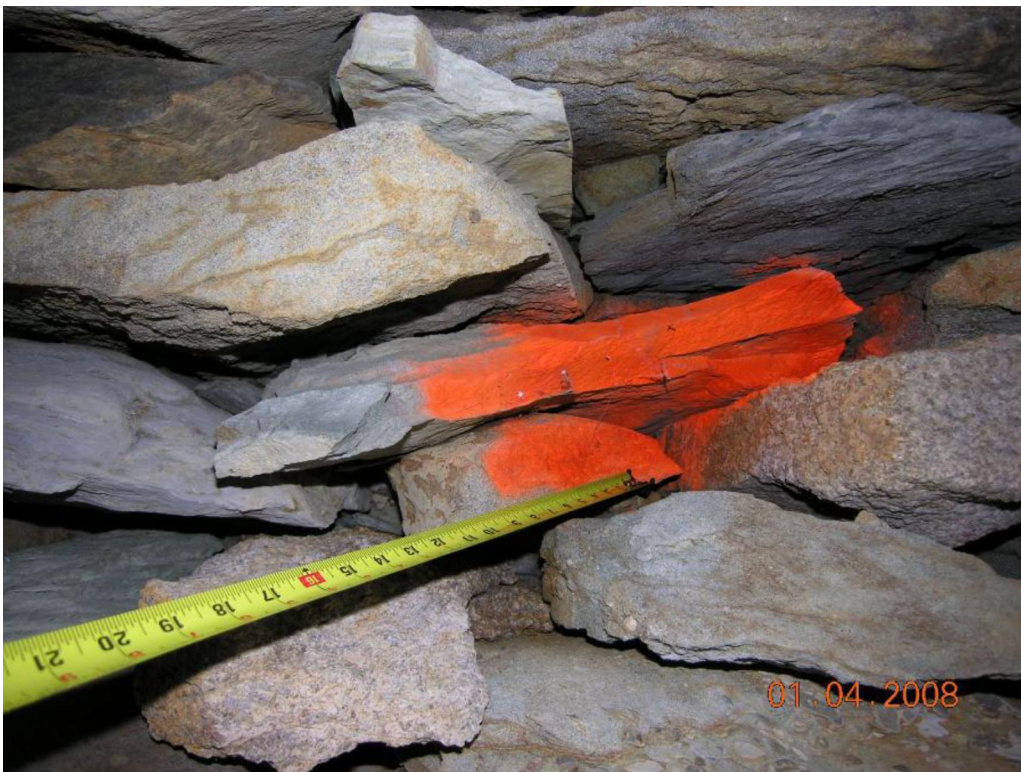
**Photo 16: Void with fractured stone, apex of middle arch, 14ft from north, 1.5ft by 7in by 1.5ft deep**

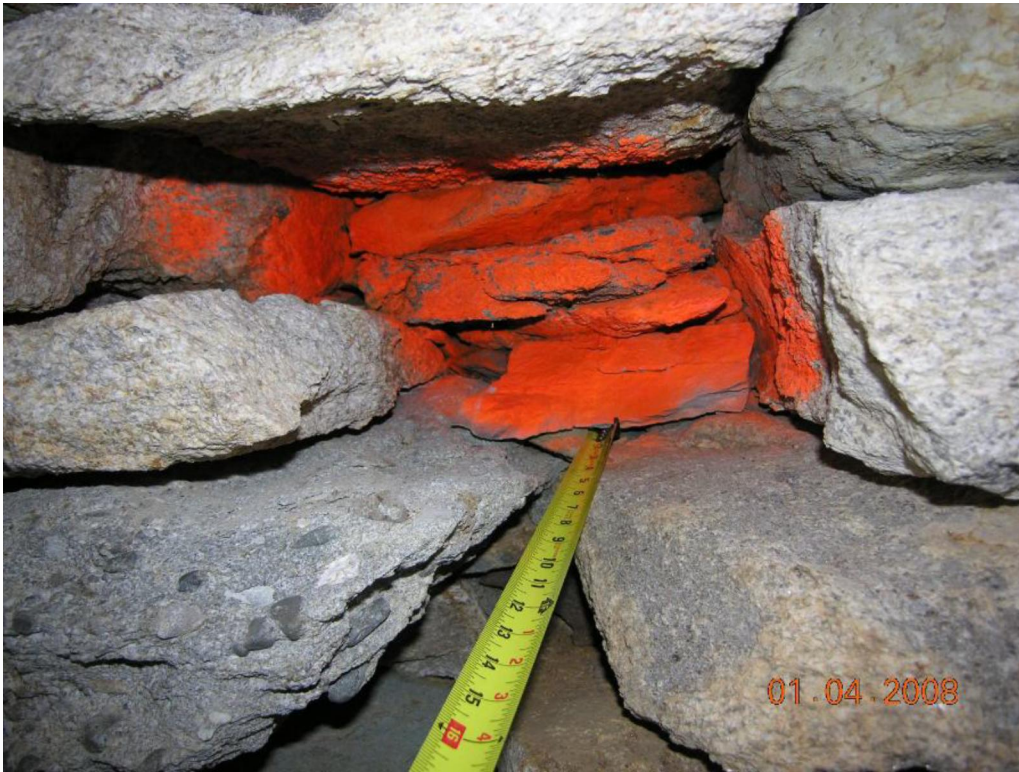
**Photo 17: Middle arch, 15ft from south, 7ft up west wall: Void up to 1.5ft x 1.5ft x 16in D**

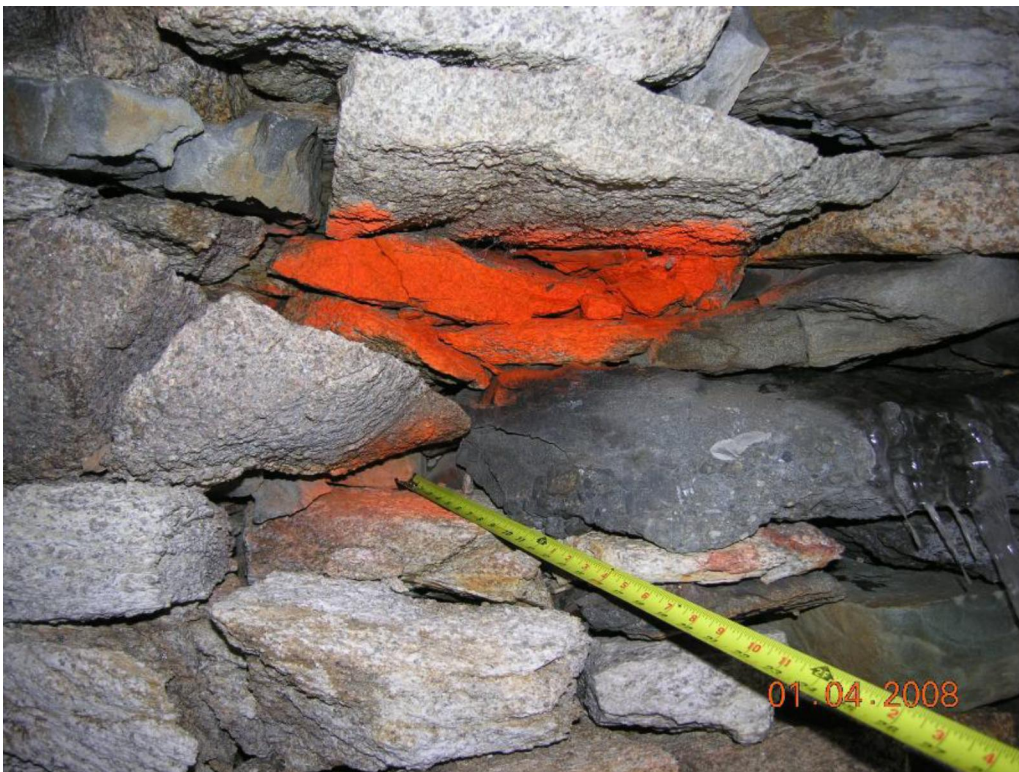
**Photo 18: Middle arch, 4ft up east side, 12ft from south: Void 2ft L x 14in W x 1.5ft D**

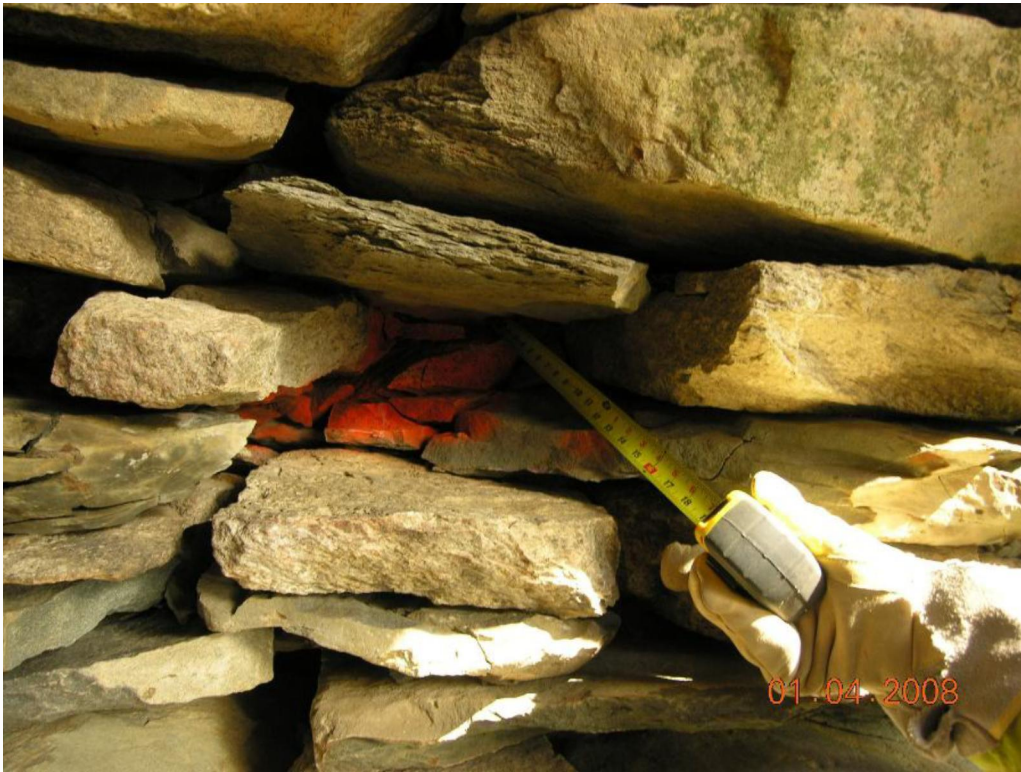
**Photo 19: South end of middle arch, 5ft up east side: Void with crumbling stones**

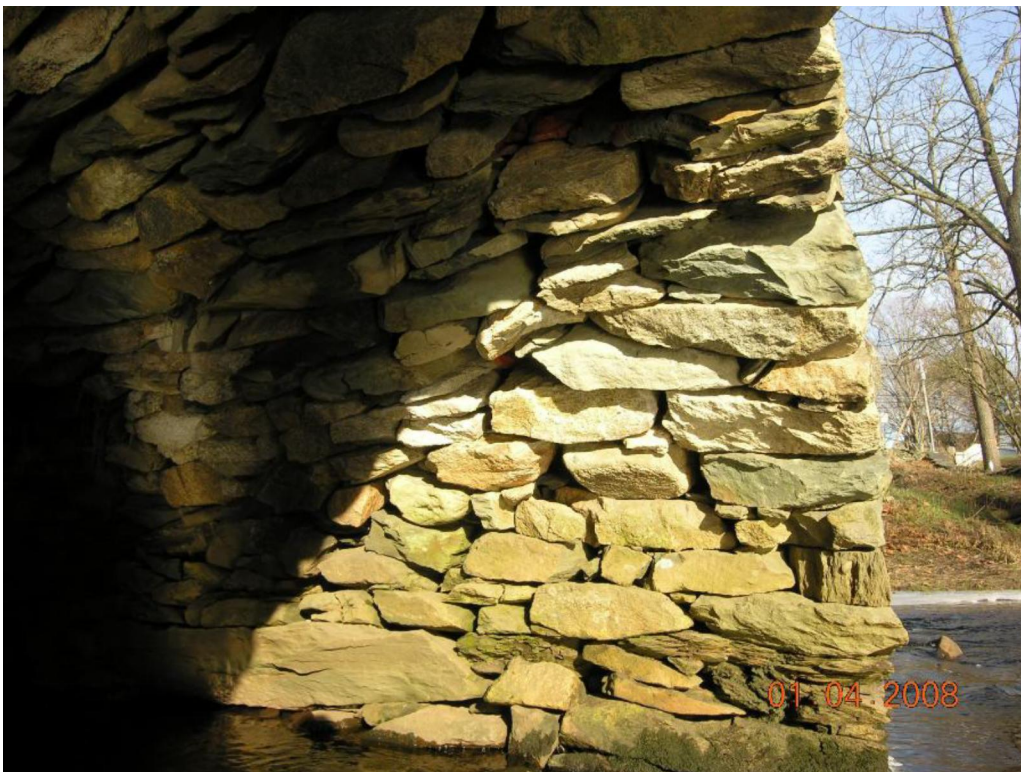
**Photo 20: Void shown in previous photo**

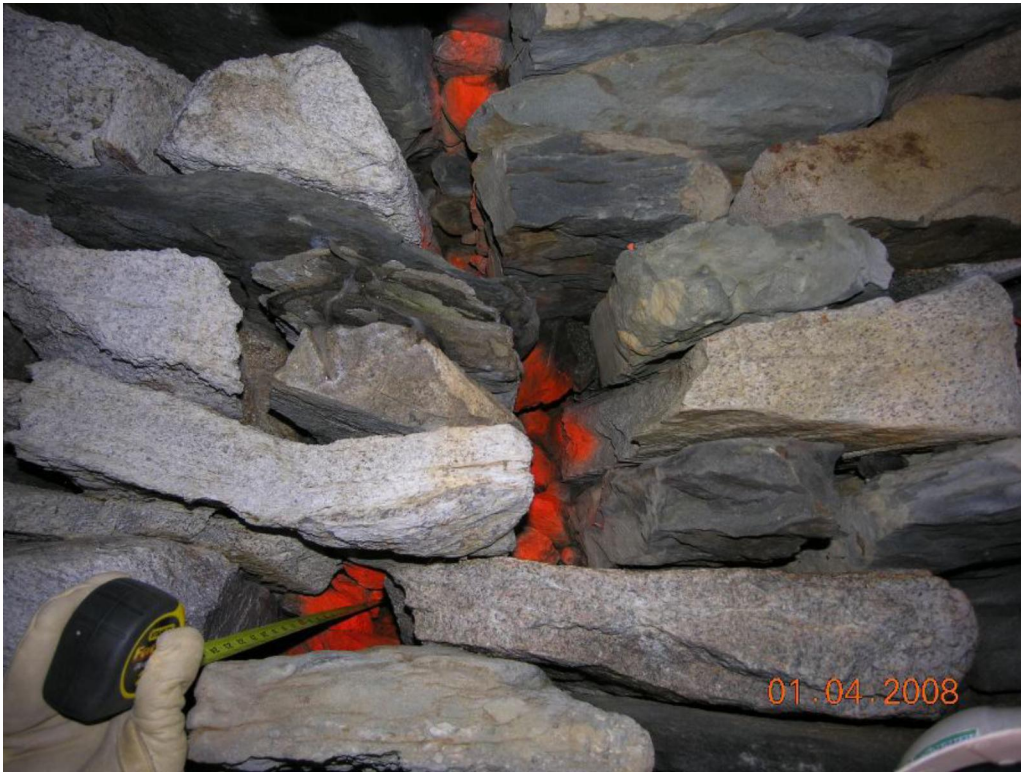
The sag in the east arch extends 12 feet in from the face of the arch ring and has 26in deep voids, also exposing the gravel fill (Photo 23). There are freshly fallen fines and stones up to about 2in diameter in the stream bed under these voids as well.

**Photo 23:** 26in deep voids exposing gravel fill at apex of east arch, 5ft from north in sagged area

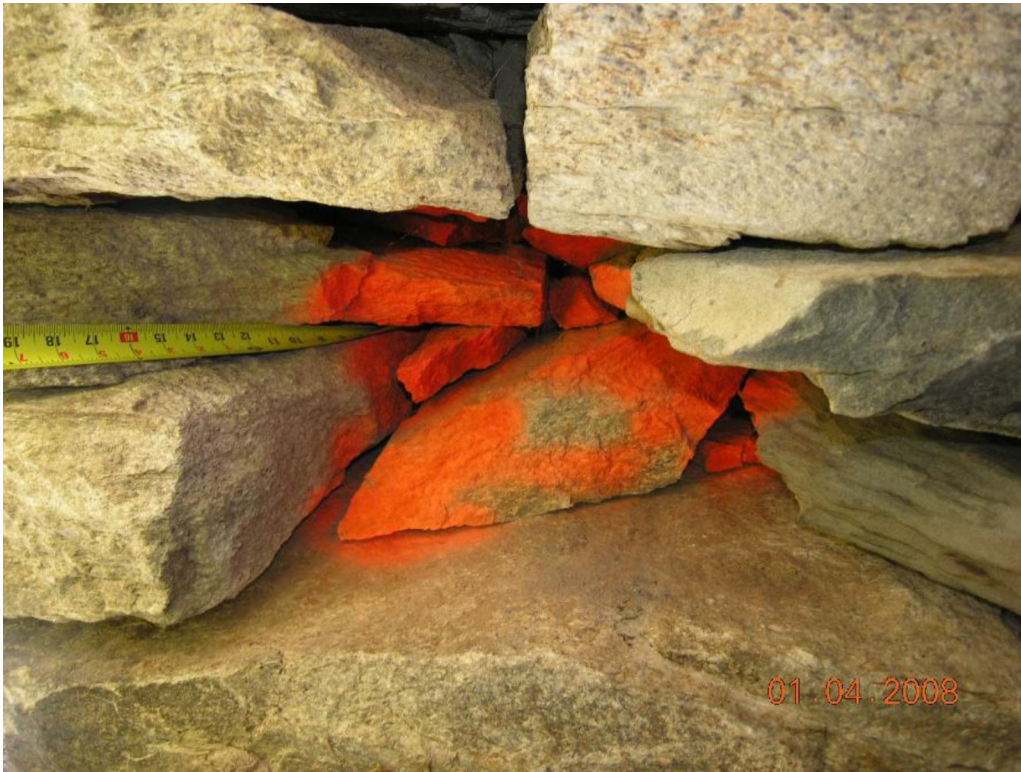
**Photo 25: East arch at southwest: Void 20in L x 1ft W x 16in D**

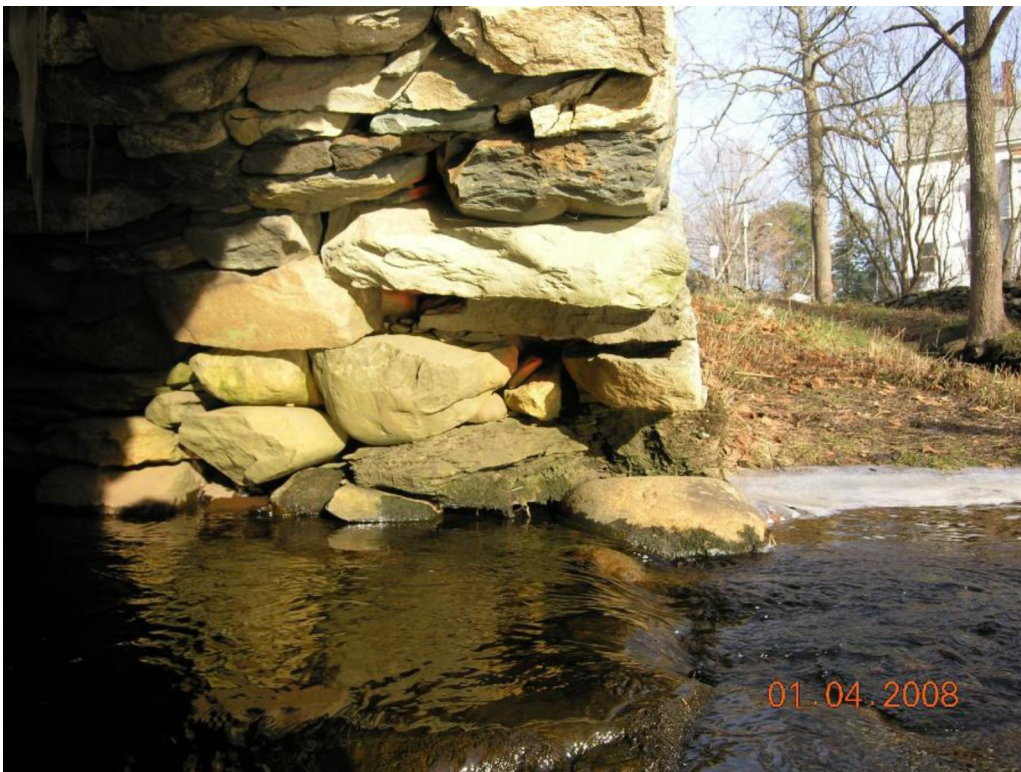
There is a large void with up to 2ft penetration under, and behind the arch ring at the SE. Water flows through this void around a stone in the bottom corner of the arch. Above it there is a partially failed, cracked, and crushed stone with point loading. This stone is in the arch ring and is below an arch ring stone that is cantilevered above a void. See Photos 26 - 28.

**Photo 26: East arch at SE: Void at bottom of arch ring/breastwall/wingwall interface 32in L x 22in H x 18in D with crushed stone**

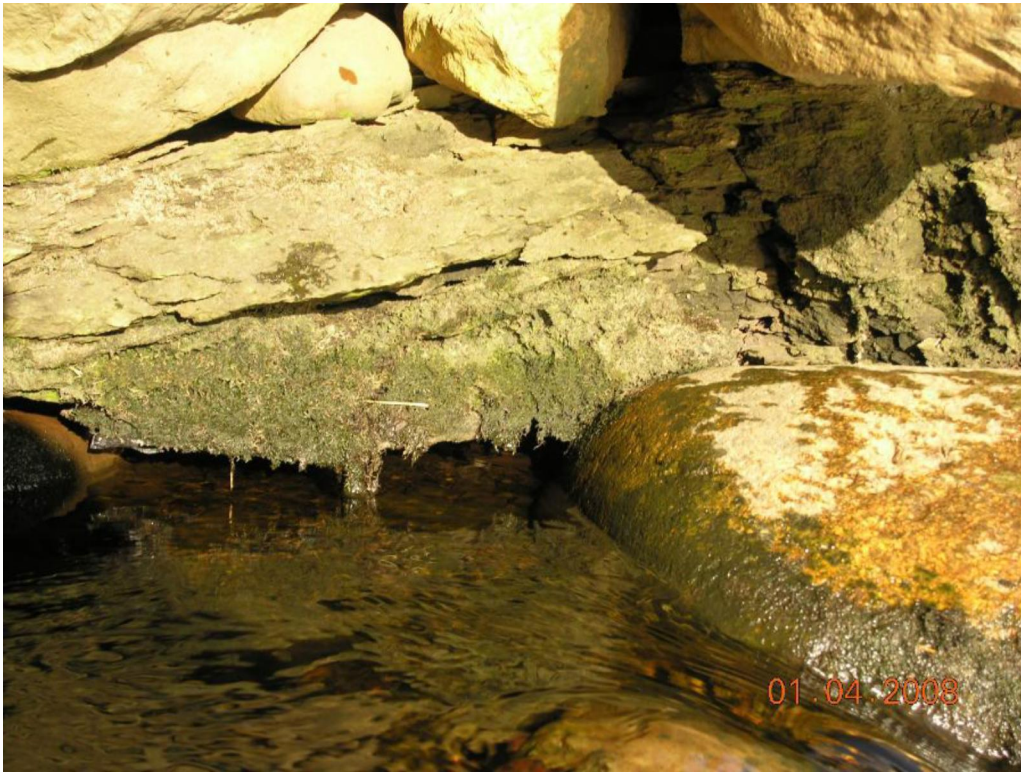
**Photo 27: Close-up of cracked and crushed stone above void**

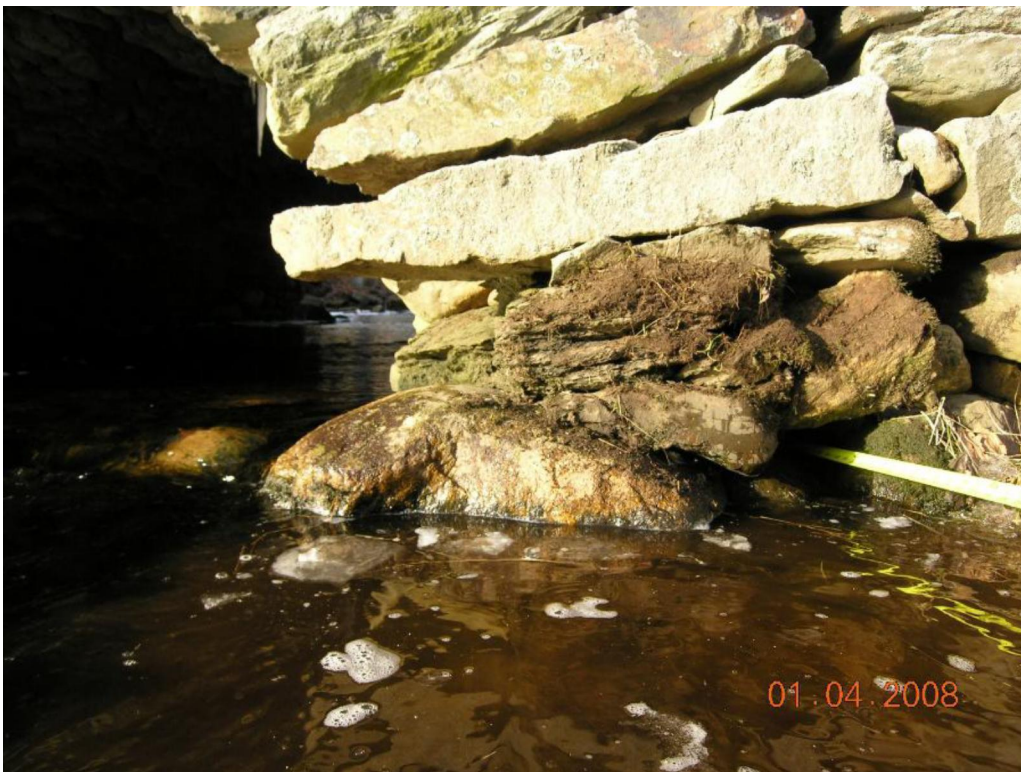
**Photo 28: East arch at SE: Bottom of arch ring with crushed stone above void with 2ft penetration, and under cantilevered stone**
